MK-1 Tip 010

CONAX Auto Inflator (NSN 1377-01-302-2560) Battery Caps

SUBJ/NAVY AND MARINE CORPS AMMO INFO NOTICE 034-2011

AUTOMATIC INFLATION DEVICE (FLU-12) (1377-JL09)//

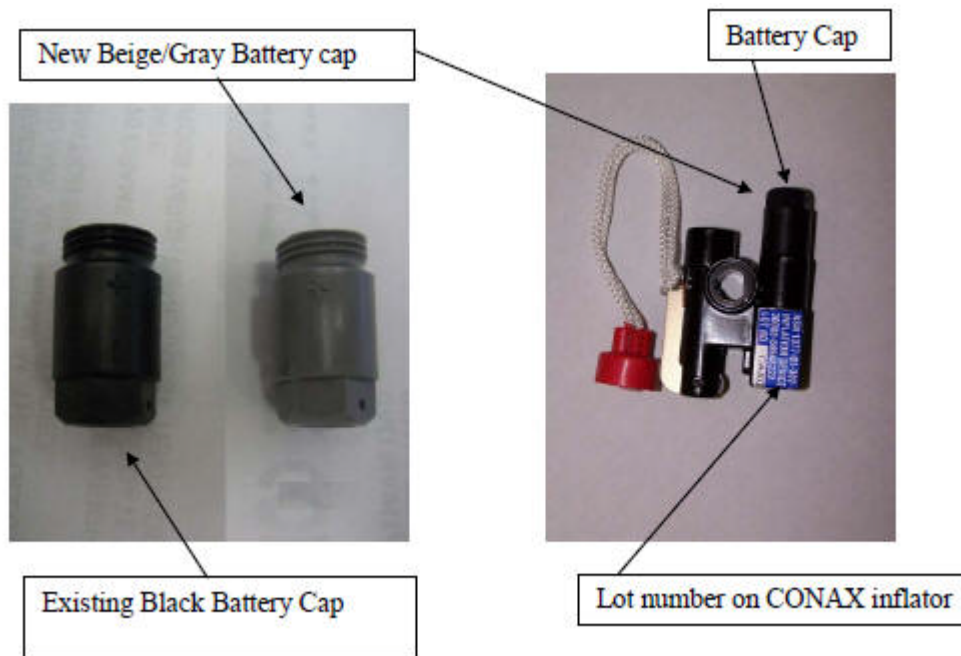
Naval Surface Warfare Center, Indian Head has determined that the battery connection in the subject inflators are susceptible to failure when used at temperatures below 20 degrees Fahrenheit. The subject inflators that have this problem were made between 2006 and 2008 with Lot numbers CAX06E001-001 through CAX08L003-015.

The investigation revealed that at temperatures below 20 degrees, the battery case can fail, causing the connection between the button cells within the battery to lose contact with each other resulting in intermittent loss of voltage. The current battery caps (black in color) only applies 1 pound of force which is insufficient to assure circuit integrity. The manufacturer, Conax Corporation, redesigned a stronger, more reliable cap (beige/gray in color). The new cap applies 8 lbs tension, holding the button cells tightly together and eliminating the failures.

Per NAVAMMOLOGCEN Naval Message 141940Z FEB 11, each ship/airwing should determine requirements for replacement caps and submit a consolidated request by e-mail to SANDRA.YANDELL@NAVY.MIL. New battery caps are a no cost item to the ship/airwing. Please provide quantity, completed mailing address, and point of contact for delivery. The black cap shall be replaced within 180 days from the date of the above naval message. When the new battery caps are received, unscrew the black cap and screw on the new battery cap. Old black battery caps are not HAZMAT and can be disposed of after being replaced.

D. REMARKS: AUTOMATIC INFLATION DEVICE, DODIC JL09,
ON THE MK-1 LIFE VEST MANUFACTURED BETWEEN MAY 2006
THROUGH NOVEMBER 2008 WAS BUILT WITH A BLACK SENSOR CAP
THAT HOLDS THE 12 VOLT BATTERY IN PLACE. THE SENSOR CAP
NEEDS TO BE REPLACED WITH A BEIGE/GRAY CAP THAT HAS
MORE TORQUE IN THE SPRING TO HOLD THE BATTERY. EACH
SHIP/AIRWING SHOULD DETERMINE REQUIREMENT FOR
REPLACEMENT CAPS AND SUBMIT A CONSOLIDATED REQUEST.
DO NOT SUBMIT INDIVIDUAL REQUEST. THE NEW SENSOR
CAPS MUST BE REQUESTED BY EMAIL TO
SANDRA.YANDELL@NAVY.MIL. PLEASE PROVIDE QUANTITY,
COMPLETE MAILING ADDRESS AND POC FOR DELIVERY. THE
BLACK CAP SHALL BE REPLACED WITHIN THE NEXT 180 DAYS
FOLLOWING THE RECEIPT OF THIS AIN.
